CASE STUDY

Jacaranda Parkway

Using CIPP to rehabilitate a 27-inch residential sewer pipeline.

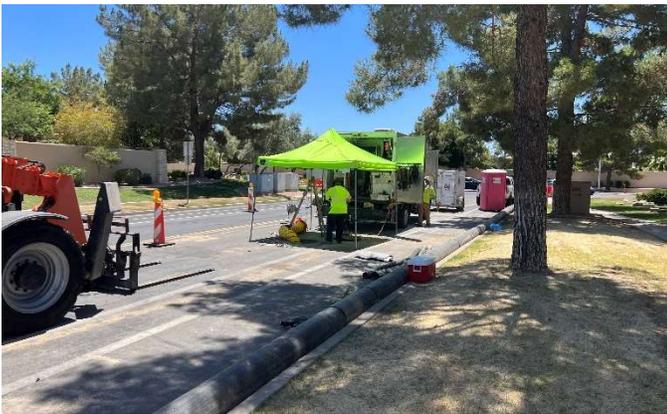
Sewer bypass along Jacaranda Parkway

The project required construction of an extremely long (approximately 4,000-foot) sewer bypass that operated continuously to maintain uninterrupted sewer services for about 2 months during the rehabilitation. The above-ground sewer bypass ran on the street, as well as in the landscaped areas off road in certain segments.

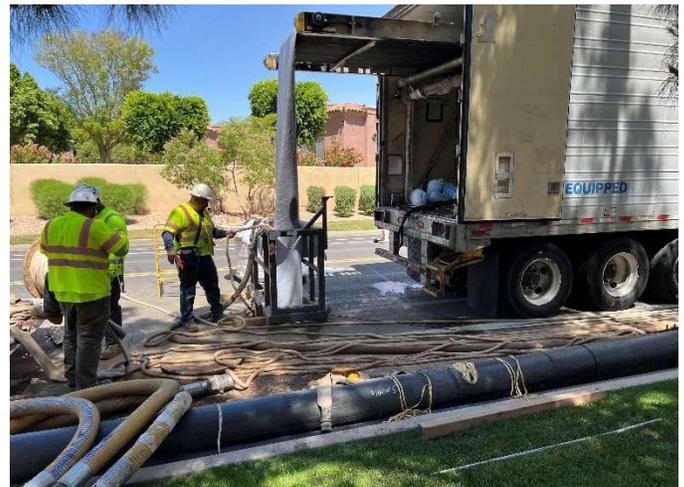
Installation of the CIPP liner

Due to the significant length of the shots, the team decided to use hot water rather than the conventional steam method to cure the liner. The hot water method required approximately 35 hours to cure, rather than the typical 5 hours necessary for steam cure. The manholes along the road were used to access the sewer line. A 4-inch hose was hooked up to a boiler to provide constant hot water circulating through the CIPP liner during the curing process. After curing, the liner was cooled down very slowly to minimize shrinkage.

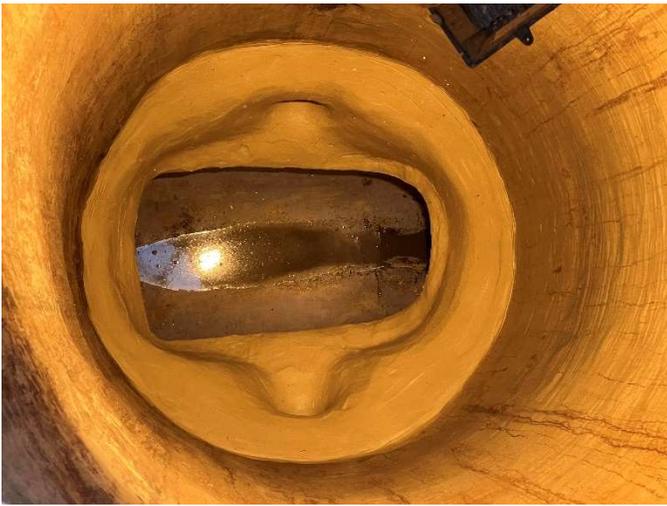
Manhole rehabilitation work was completed on 13 manholes

Manhole rehabilitation work included coating the bench and channel of 13 manholes. The bench (above the sewer line) is the very bottom of the manhole that connects to a channel, while the channel (at the sewer line) connects the pipes from one space to the next.
